## The Marausa Wreck, Sicily: interim report on a boat built in the Western Imperial Roman tradition

In 1991, the wreck of a late 3rd–early 4th century AD Roman merchant vessel was discovered on the west coast of Sicily that had carried North African amphora, *tubuli*, and other ceramics. The hull was dismantled and raised in 2011, including a keel hook-scarfed to stem and sternposts, 39 pegged mortise-and-tenon joined planks, 43 frames with an irregular pattern of floor-timbers, half-timbers, and futtocks fastened to the planking with trenails and copper nails, sister-keelsons and evidence of two stringers, 36 ceiling strakes, and the base of a bilge pump. Many repairs are indicated. The fairly flat bottom and round bilges, mortise-and-tenons, sister-keelsons and lack of a coherent framing pattern, place the boat in the Western Imperial tradition.

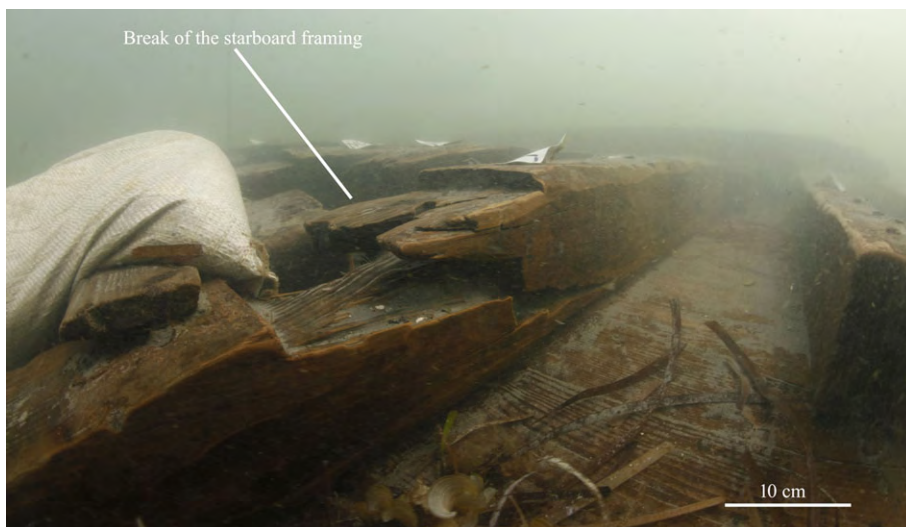
of the starboard side were broken at a distance of *c.* 1.40 m from the keel, because of the underlying profile of the seabed (Fig. 6). Two sister-keelsons, two sleepers, and remains of two stringers were found. Some 36 ceiling strakes and the base of a bilge pump also survived, similar to that found on the Madrague de Giens (Carre and Jezegou, 1984: 116–20).

Figure 6. An example of the breaks seen in the starboard frames. (Photo: R. Rinaldi with permission)

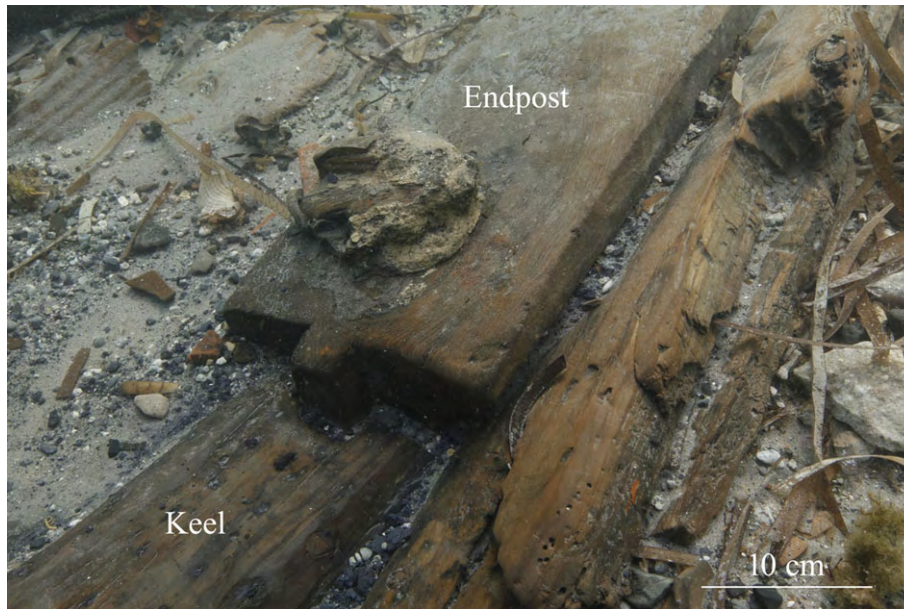
At its ends, the keel was connected to the stem and the sternpost by means of two keyed hook-scarfs, each reinforced with a metal bolt, giving a total length of 10.40 m (Fig. 8). This feature is comparable to those seen in the Monaco and Siciliano Bay wrecks (Liou, 1973: fig. 69, Riccardi, 1998: 86, Pomey *et al.*, 2012: 246). At the bow, a long copper nail, about 0.27 m in length, inserted from the underside at an angle of about 60°, reinforced the scarf. A similar configuration is described by Beltrame and Gaddi for the Grado wreck where iron nails were used in the sternpost (Beltrame and Gaddi, 2007: 138–42).

Figure 8. The keyed-hook-scarf and bolt fastening the keel and stem. (Photo: Authors)

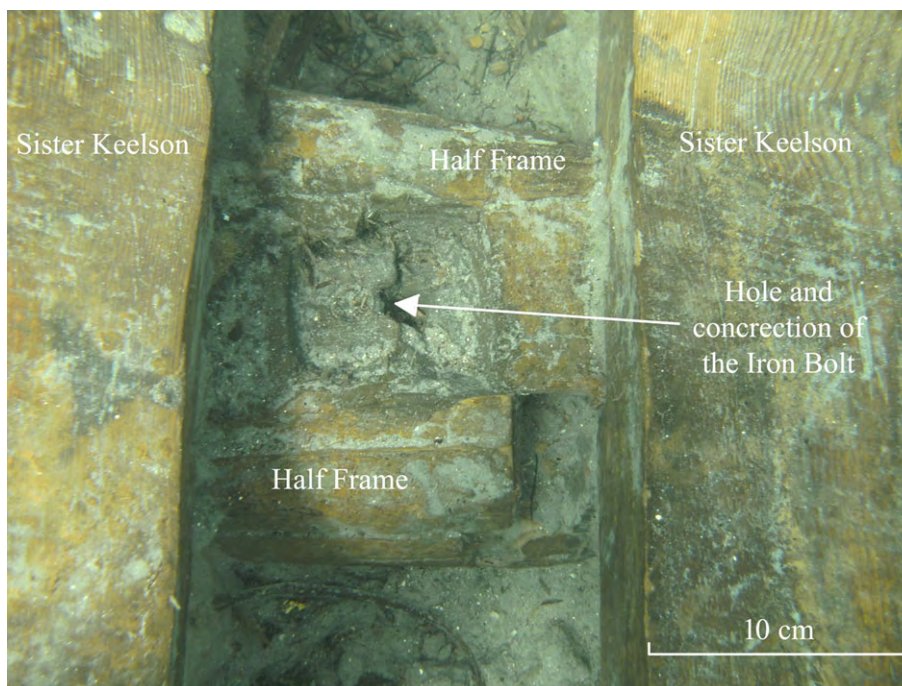
The master-frame, F26, is easily recognized, consisting of two half-frames joined in a three-planed scarf keyed with a large iron bolt, which also fixed it to the keel (Fig. 11). It is about 0.25 m forward of the centre point of the keel. Only three frames, the master-frame (F26), F40 (now lost), and F1, found *in situ*, were iron bolted to the keel, and in the last two cases, the iron bolts also secured the keyed hook-scarfs that connected the keel to the stem and to the sternpost. All the other frames are fastened to the planking with round-section treenails, diameter 12–16 mm, usually two for each strake, inserted from the inboard and, in at least 90 cases with no obvious pattern, not completely passing through the hull planking. On both sides, from the bottom of the hull up to the height of two hold-stringers, treenails are the sole fasteners used. From the stringers up, copper nails, driven from the outboard, were also used, particularly to secure the tapering ends of some of the planks, and for repairs.

Figure 11. Detail of the central bolted scarf of the master-frame. (Photo: Authors)

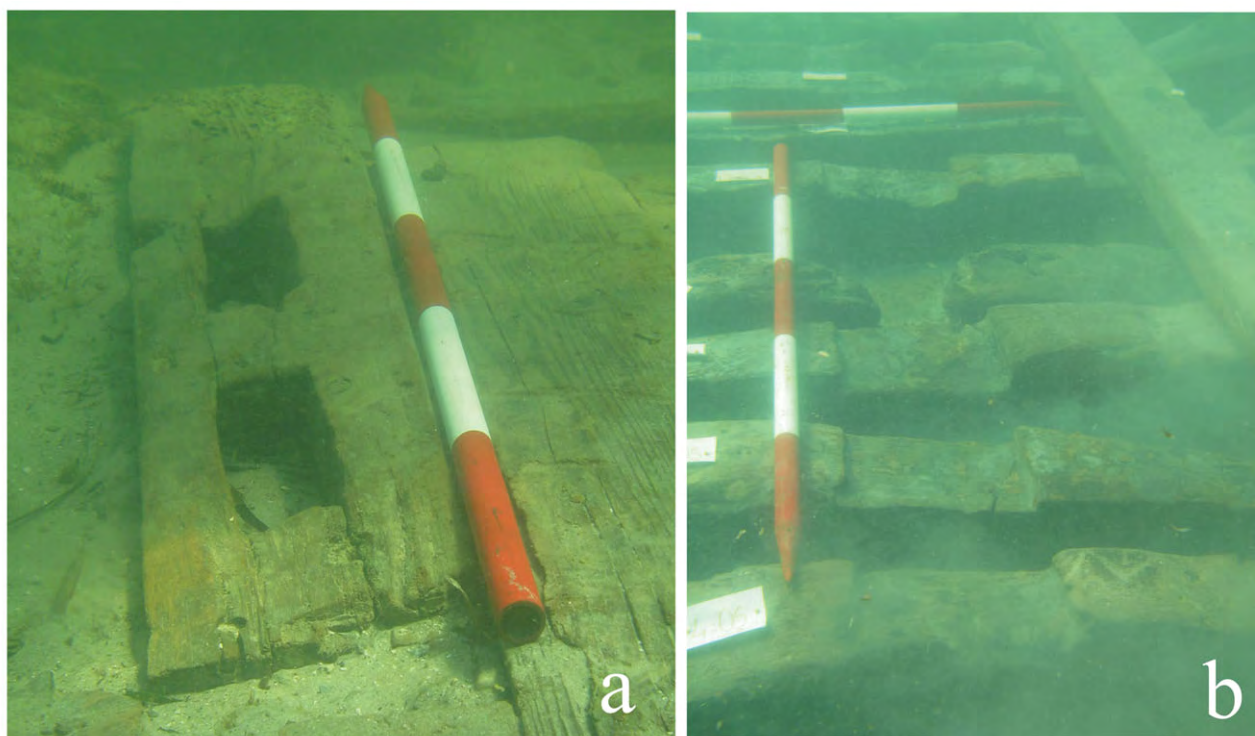
bilge pump (see Carre and Jezegou, 1984: 116–20). The upper face of three frames have been carved to create a square pump well able to host the base of a chain pump, while one of the frames is shaped to permit the passage of rope and discs (Fig. 14). The discovery of a series of small, thin wooden planks (0.12×0.20 m and 10 mm thick) in this area also suggests that the pump well could have been closed (see Carre and Jezegou, 1984: 130, Gassend *et al.*, 1984, fig. 21). The location of the base of the bilge pump interrupts the pattern of ceiling planks on the lower port side. Only the wooden base block of the bilge pump is preserved. The pump block was nailed to the framing in two places with copper nails. The block has two square holes and shaping to allow the passage of the chain-pump system discs or valves.

Figure 14. a) Bilge-pump base and b) frames shaped to host the bilge-pump base. (Photos: Authors)

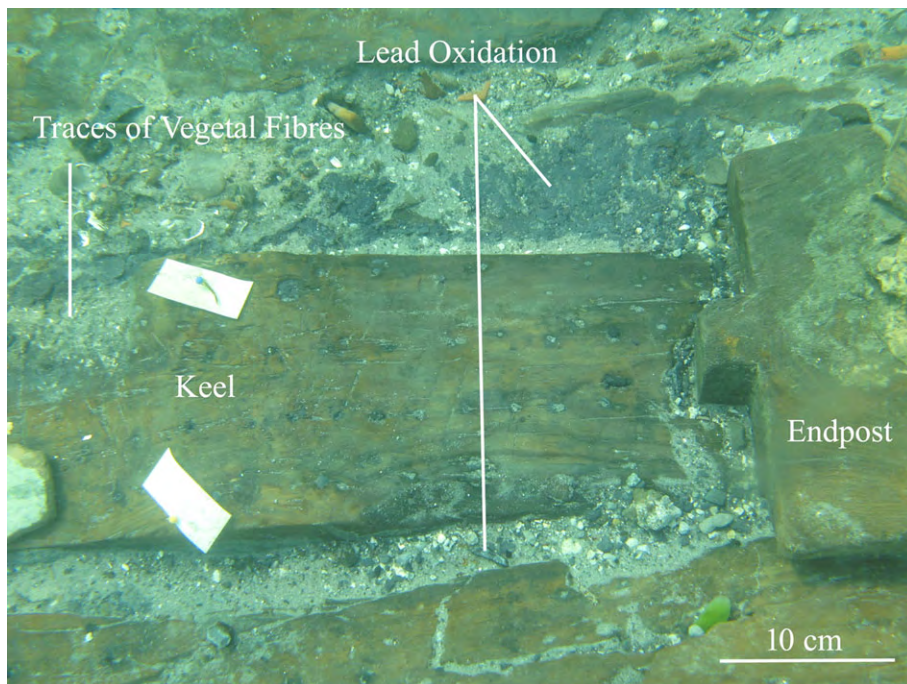
Lead was also used to seal planking seams. At least three small lead patches were secured to the planks, usually from the outside, with round copper tacks. Once the planking was removed, the pattern of dark grey traces of oxidation left on the seabed by lead patches nailed to its outer face was recorded. These repairs, particularly those below the waterline, were made from the outboard and reinforced with a sheet of lead nailed from the inside.

Figure 15. Traces of lead patch repairs in the bow end. (Photo: Authors)
